# Liquid Oxygen Cylinder Explosion

- **Improper methods used to render scrap cylinder unserviceable**
- **Unsafe modifications to cylinder design**

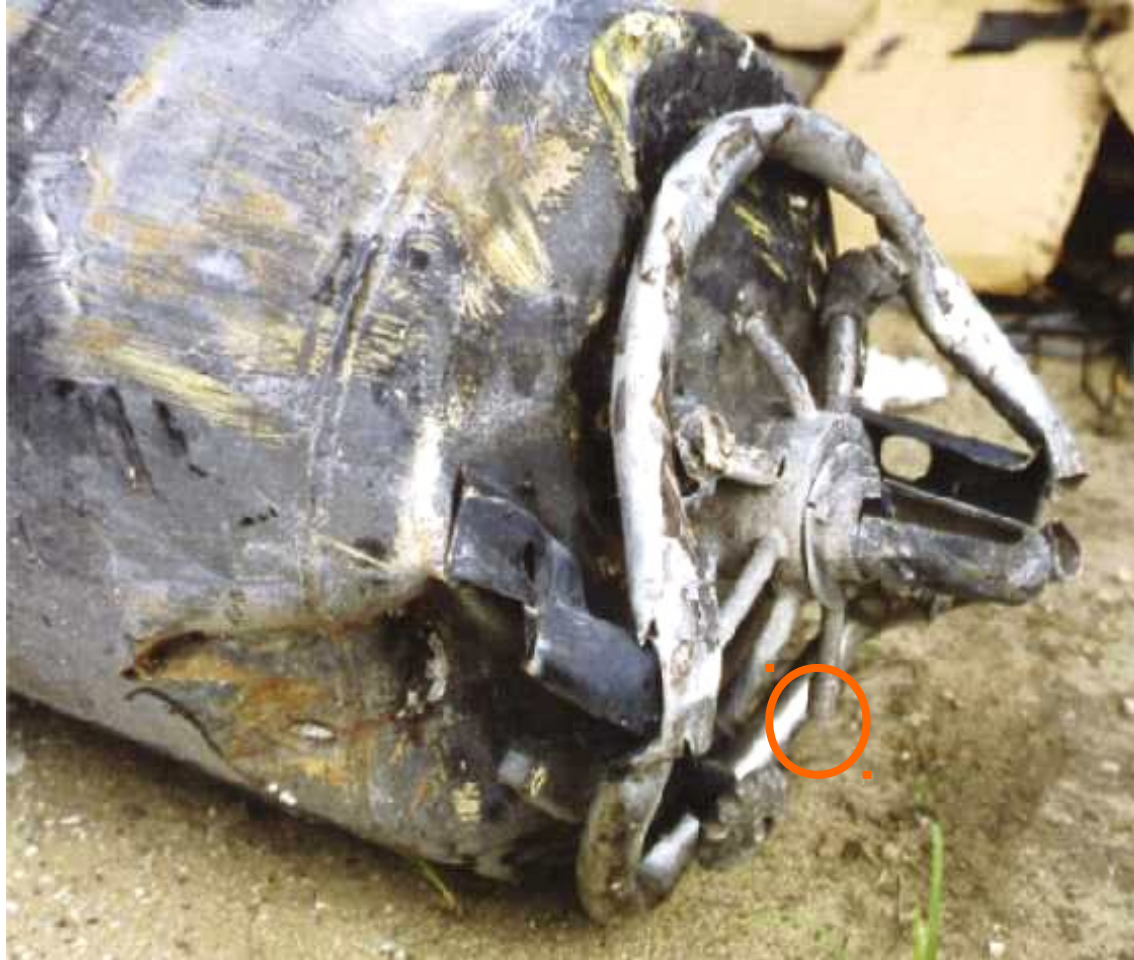
PRD location was plugged using a threaded cap

Plug/Cap

Hole in  
vacuum port

- The PRDs were removed and plugged
- The cylinder was filled while onboard a pickup truck
- The cylinder, which had no vacuum, was now unable to vent excess pressure

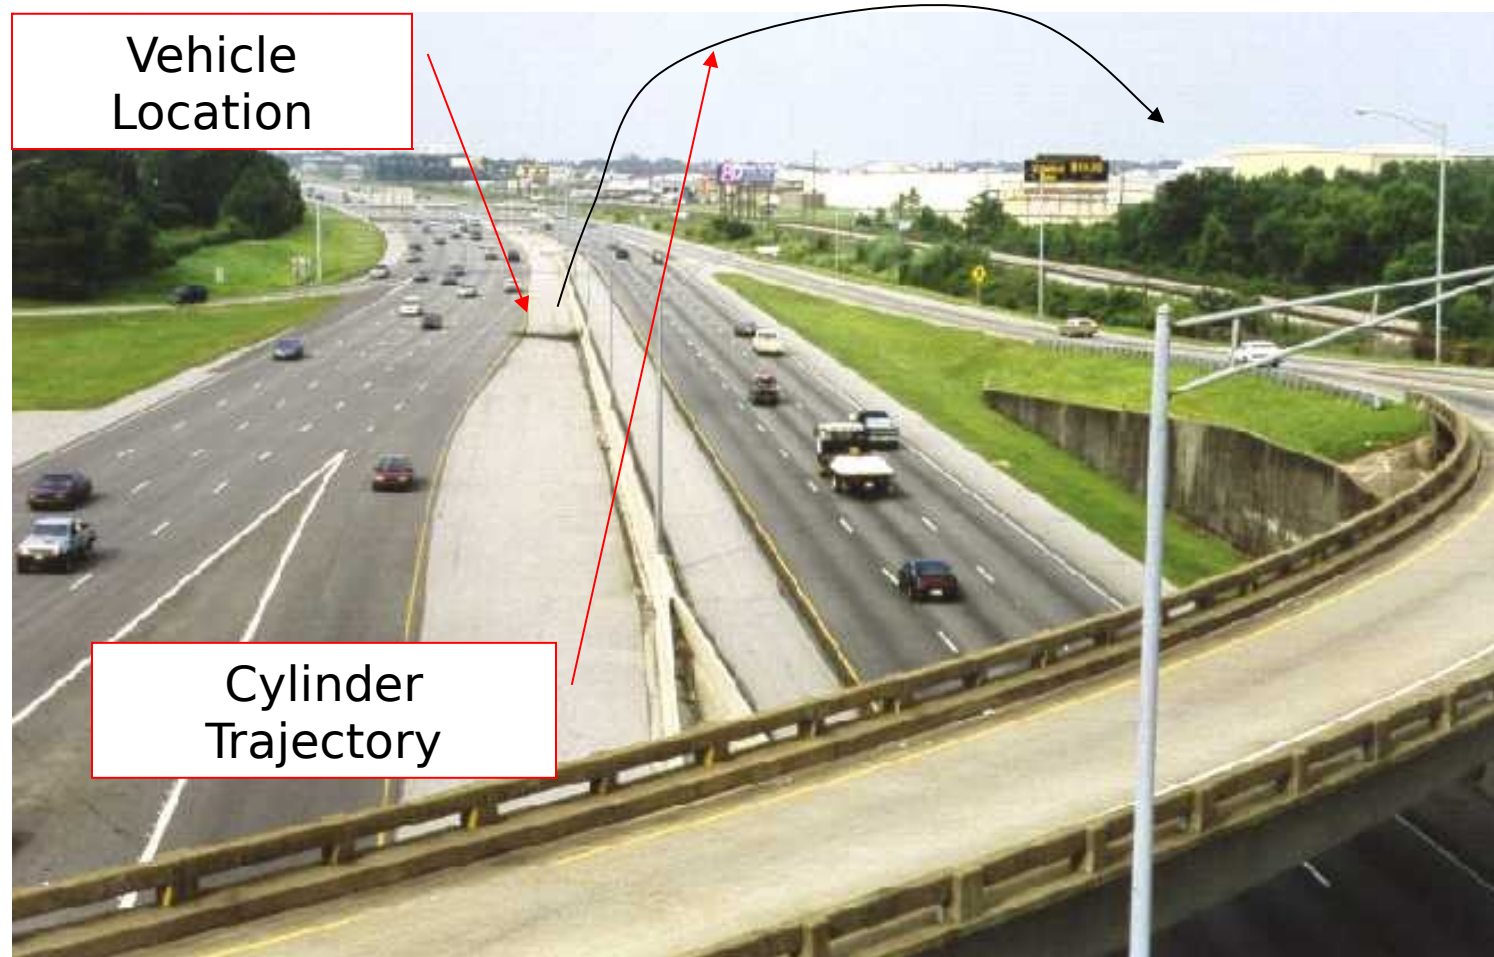
Cylinder exploded at 12:40 PM while transport vehicle was parked on busy Interstate highway

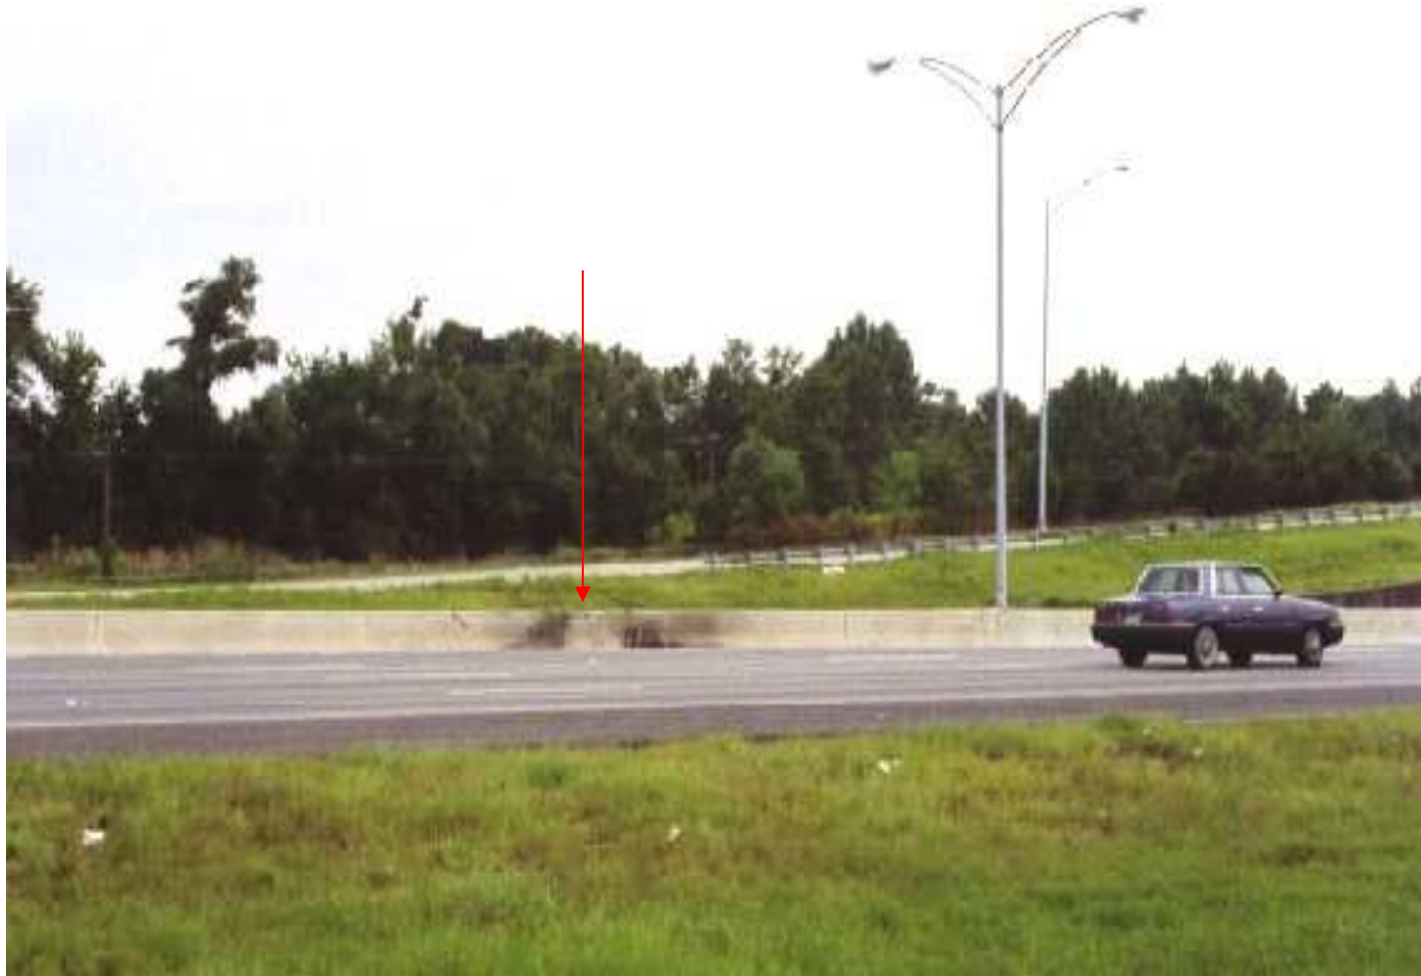
The blast blew one individual across 5 lanes of traffic. The other was blown approximately 40 feet. Both survived

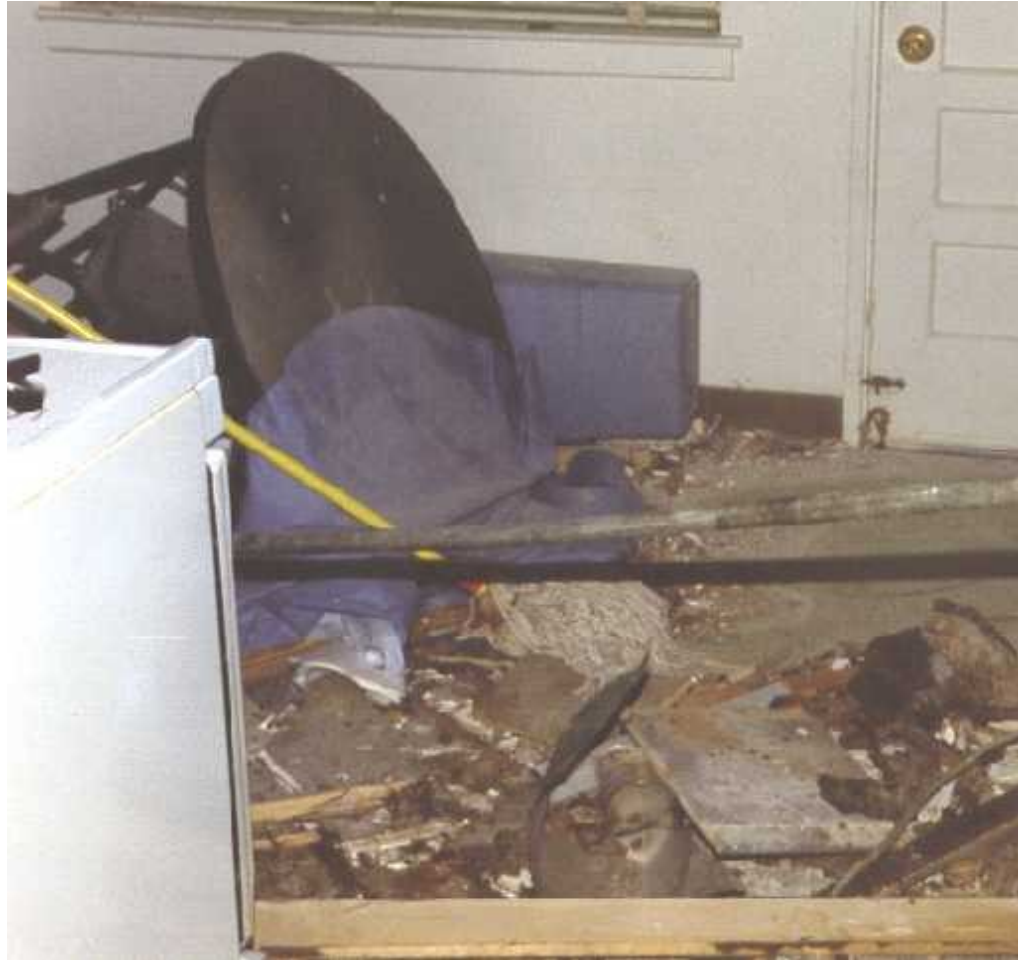
Despite heavy damage, no injuries to apartment tenants were reported
